PRECISION DYNAMICS LAKE DAM

LOUDOUN COUNTY, VIRGINIA

PHASE I INSPECTION REPORT

NATIONAL DAM SAFETY PROGRAM

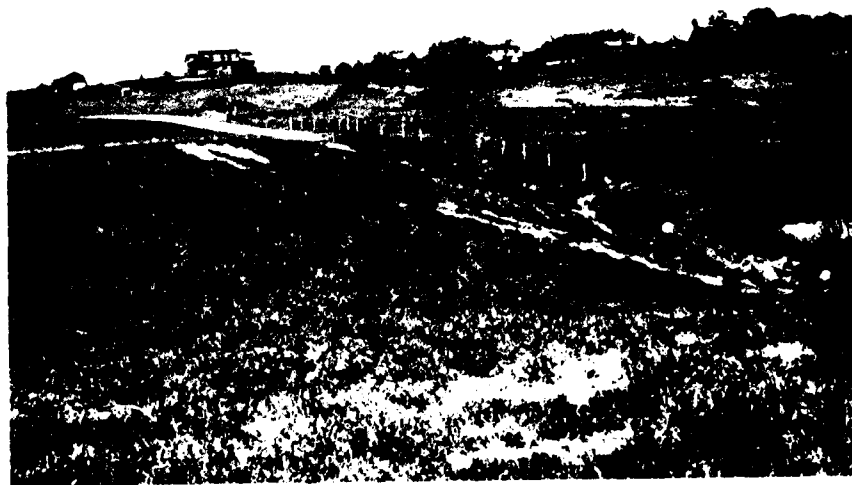
Photograph No. 2 - Downstream Face of Dam

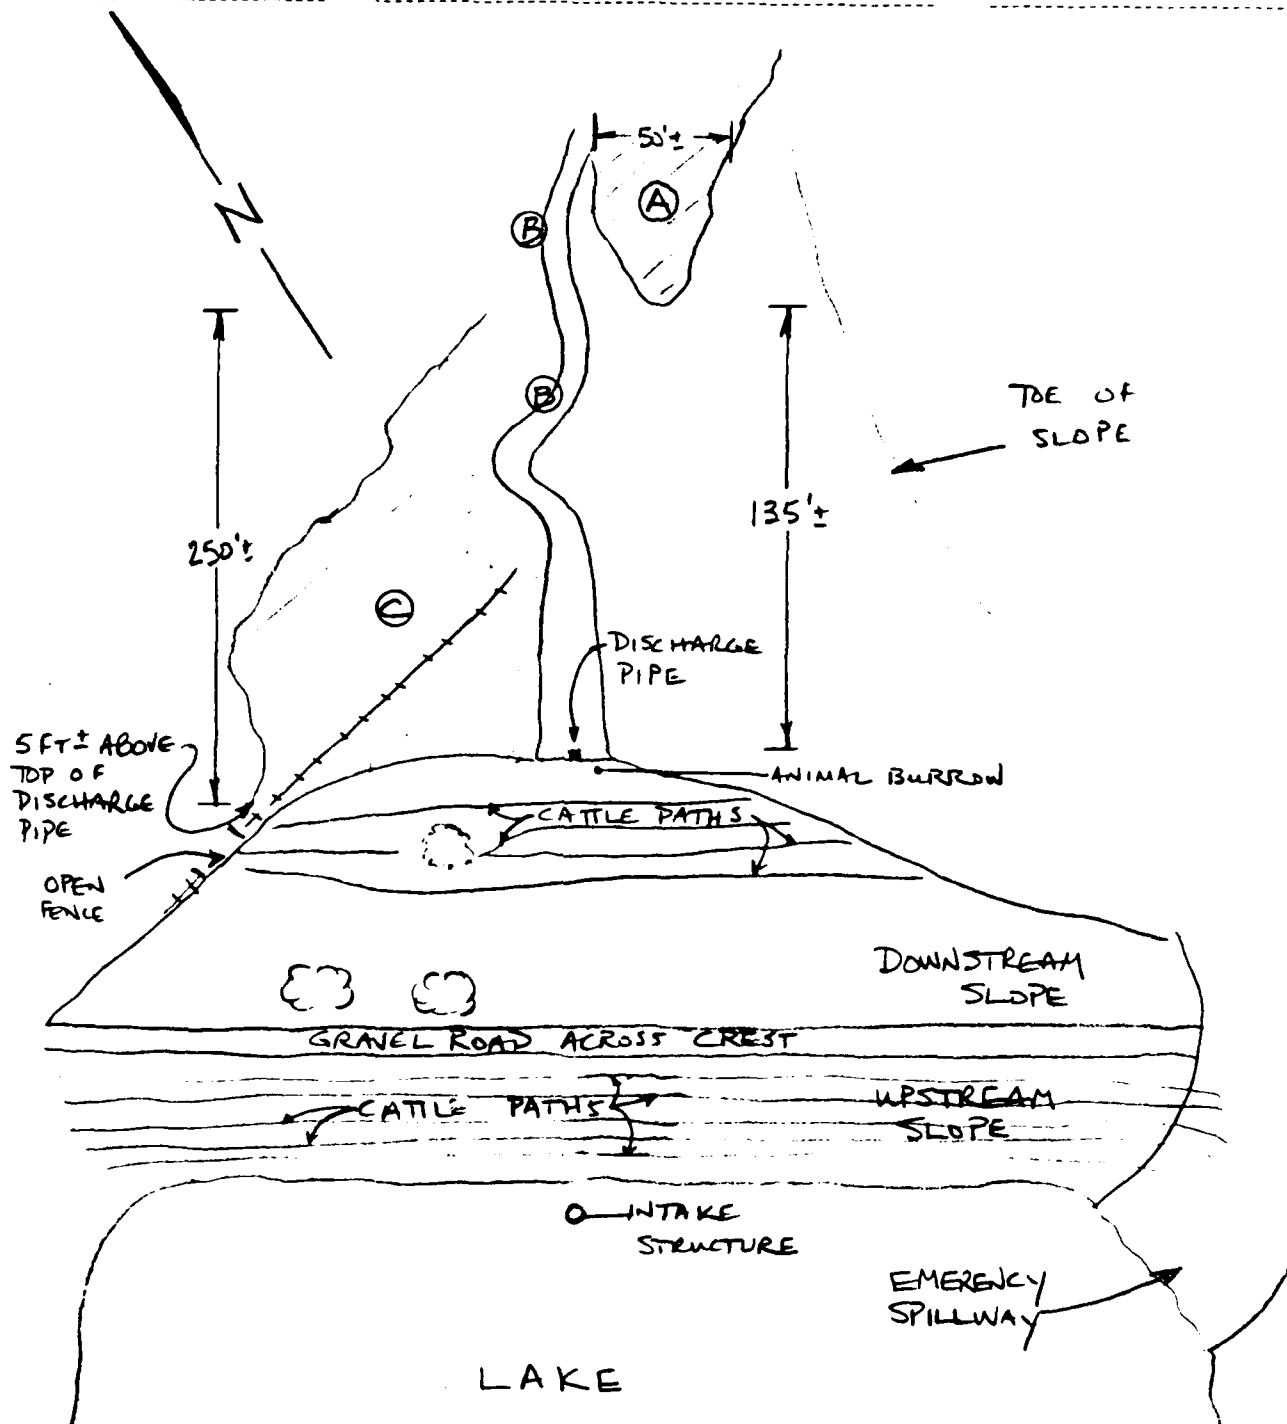
Along the left downstream toe the ground is saturated and includes scattered marsh grass. This area extends to a point 8 ft above the discharge pool along the left abutment/embankment contact. Scattered iron staining and the presence of films on some ponded areas were noted, however, no flow was observed. Some iron staining was also encountered 100 ft⁺ below the discharge pipe along the stream channel. A ⁺ 200 ft long saturated, marshy area occurs along the right side of the stream approximately 135 ft below the dam (Field Sketch 3, Appendix III).

The marshy saturated areas located below the downstream slope on the left and right sides of the discharge channel are believed to be related to spring activity. Iron stained areas observed on the left side may be related to seepage through the dam near the left downstream abutment-

embankment contact. This does not necessarily create an unsafe condition; however, these iron stained areas should be monitored periodically in attempt to detect any significant increases in flow which may result in piping within the embankment.

- (A) SCATTERED MARSH GRASS AND SATURATED GROUND; EXTENDS SEVERAL 100' DOWNSTREAM, SOUTH END OF AREA IS 5 FT ABOVE TOP OF DISCHARGE PIPE. NO FLOW OBSERVED.
- (B) SCATTERED IRON STAINING ALONG BOTH SIDES OF STREAM NO FLOW OBSERVED.
- (C) MARSHY AREA WITH CATTAILS OCCUPYING THE UPPER 75'± OF THE AREA. GROUND IS SATURATED. SCATTERED IRON STAINS AND FILMS ON STANDING WATER NOTICED. NO FLOW OBSERVED.

7.3.5 Iron stained seepage present in the marshy area below the left downstream abutment-embankment contact should be monitored quarterly to detect any increase which may cause piping within the embankment.
